Sadakathullah Appa College

7.1.4 WATER CONSERVATION FACILITIES

MAINTENANCE OF WATER BODIES AND WATER DISTRIBUTION ON THE CAMPUS

6. Water Audit

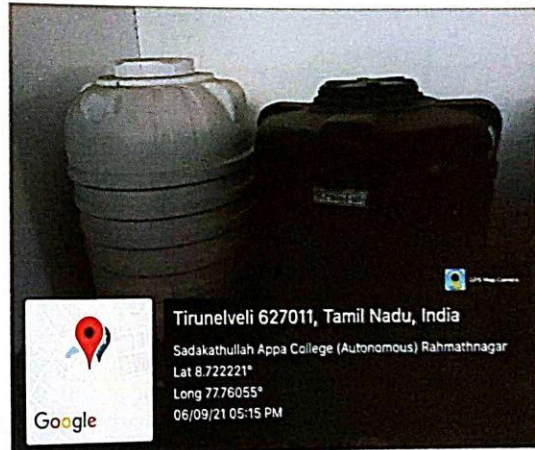
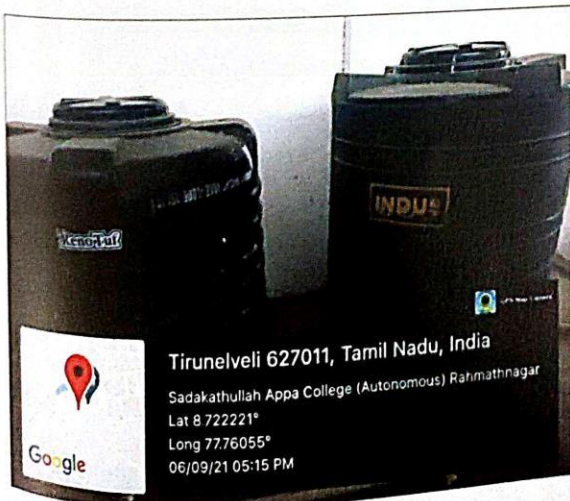
On-site investigation and physical verification
Facilities related to water consumption and usage in the premises

- **There is no water leakage in the entire premise;** the pipes are well maintained with adequate hygiene.
- **The premise has an efficient water management in terms of operations and maintenance.**
- The toilets are kept very tidy and are cleaned every day.
- **The waste water does not mix with ground water and gets directed to storm water drains.**
- **The college has natural rainwater harvesting system which is very useful.**
- There are sufficient numbers of taps in the premise.

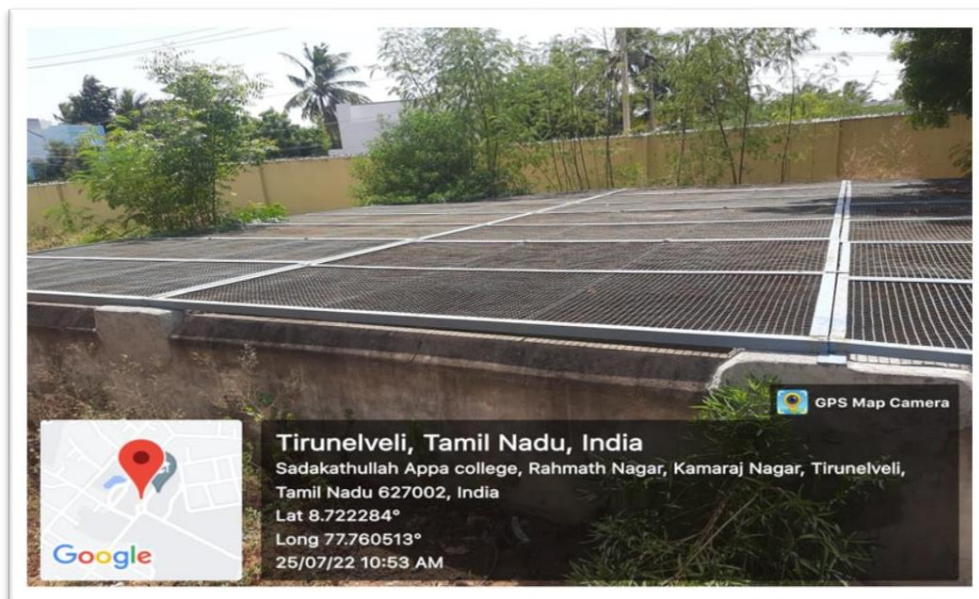
WATER DISTRIBUTION SYSTEM ON THE CAMPUS - OPEN WELL

b) Well (Rain Water Harvesting) – There are Well in the premises, the system is designed to store and reuse rainwater. The water collected on the roofs of all the buildings in the college is discharged into the ground through appropriate piping system and sanitation system so that bore well benefit from this accumulated rainwater in the future. **The Rain water harvesting is done through the roof water being used for bore well recharging.**

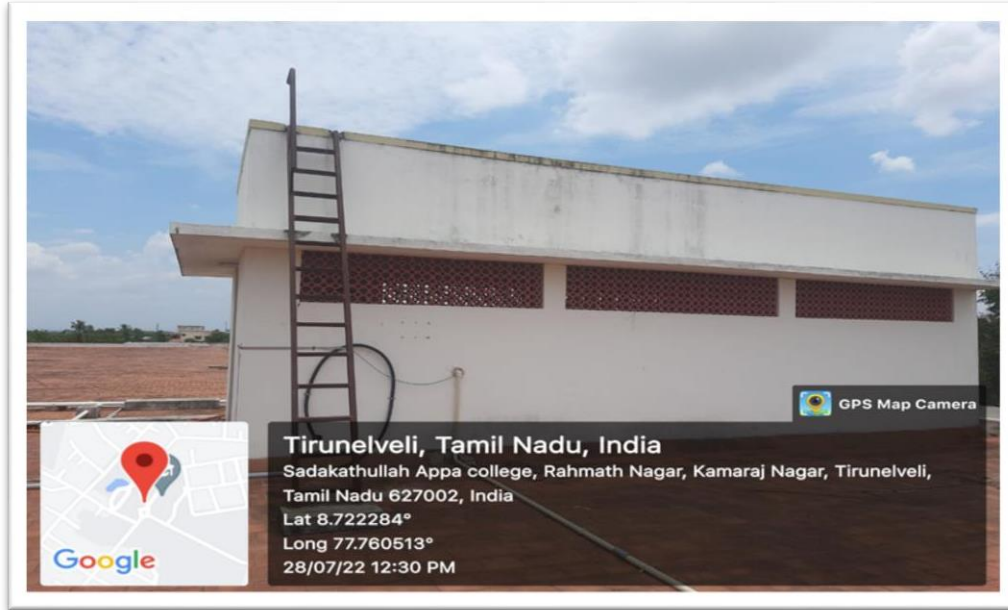
WATER DISTRIBUTION SYSTEM ON THE CAMPUS - TANKS

The main source of water is through Bore well. The College requires only drinking water from the Local Municipality. The total water consumption through the tanks on site, these are available in a quantity of 5 tanks at various locations. The capacity of each is as follows:
